PBY Catalina

Walk Around

By William Scarborough

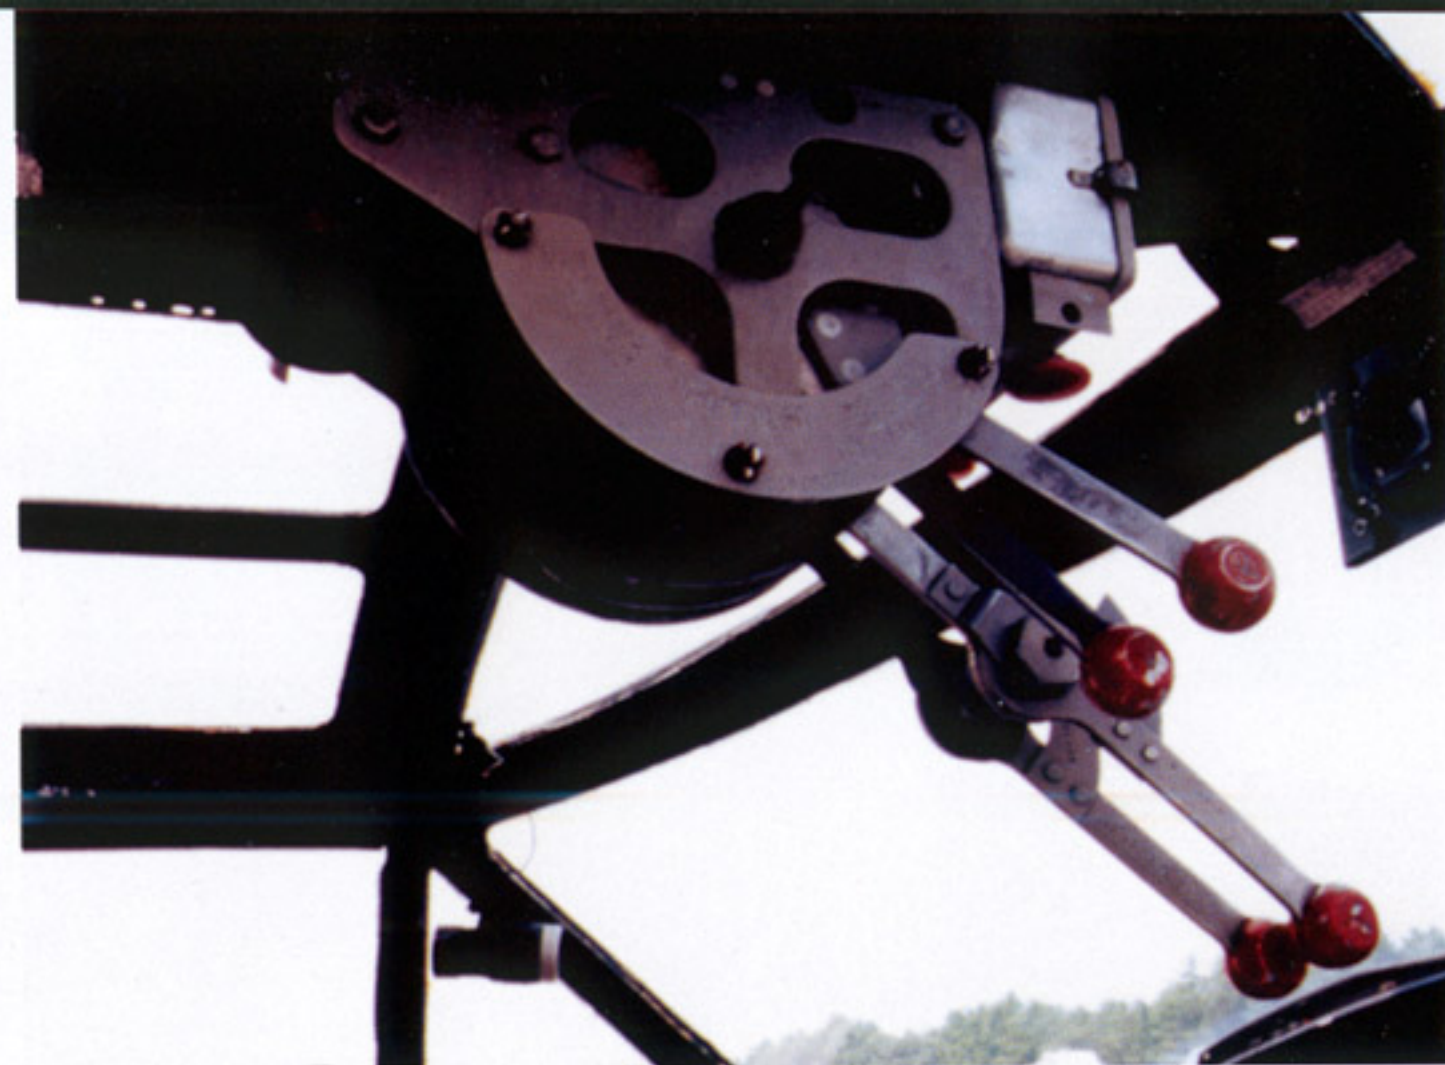
The throttle and propeller controls were located overhead between the pilots. (Mike Bobe)

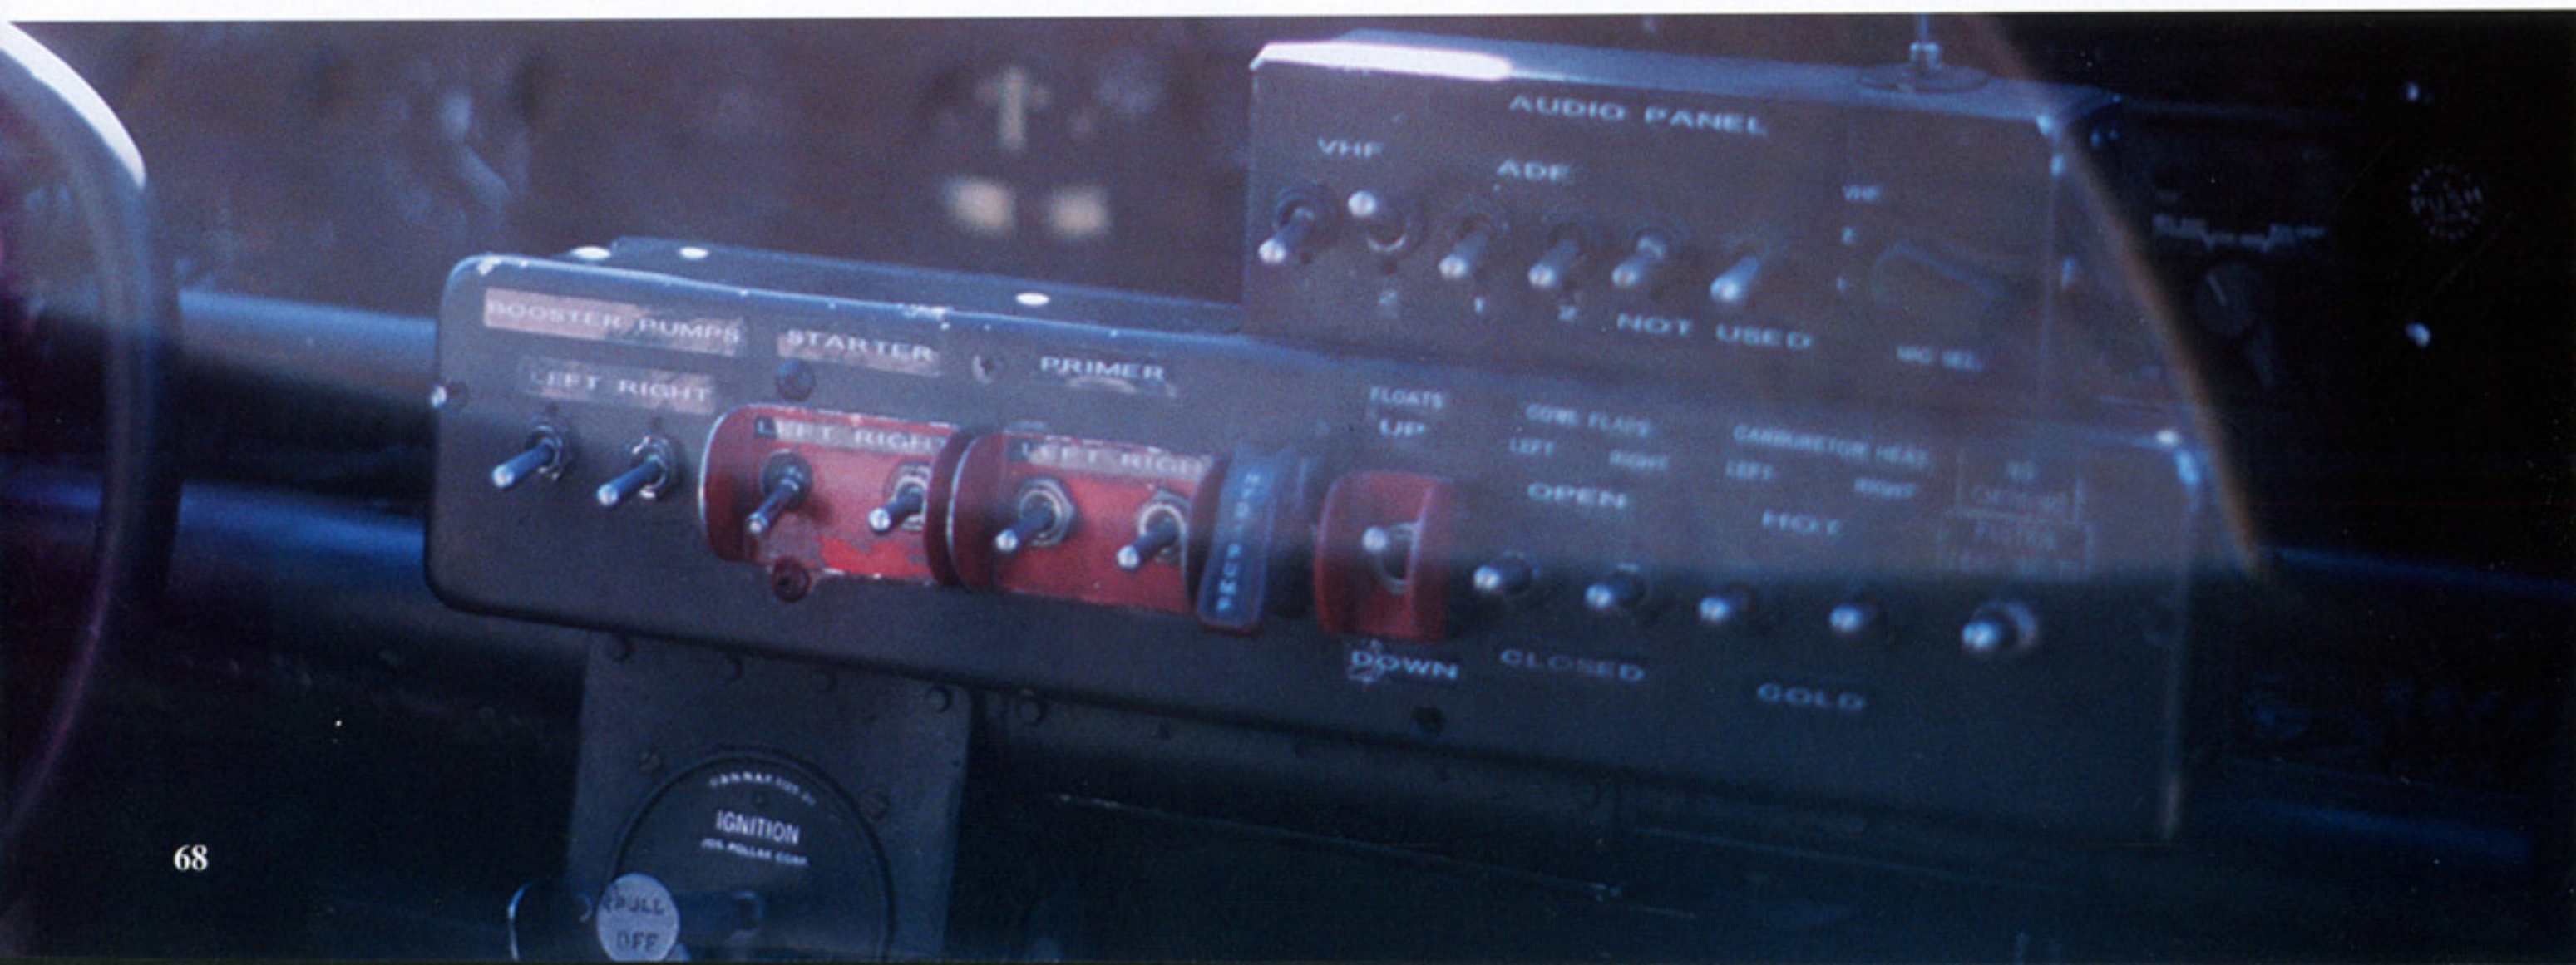
This is the engine control panel in the cockpit of the Confederate Air Force PBY-6A. The switches at the left are for engine start and include the booster pump, primer and starter switches for each engine. The float retraction switch is the Red switch in the center of the panel, next to it are the cowl flap switches and carburetor heat switches. The round switch below the panel is the main engine ignition controls. These modifications were required by the deletion of the engineer's station in the pylon. (Mark Aldrich)

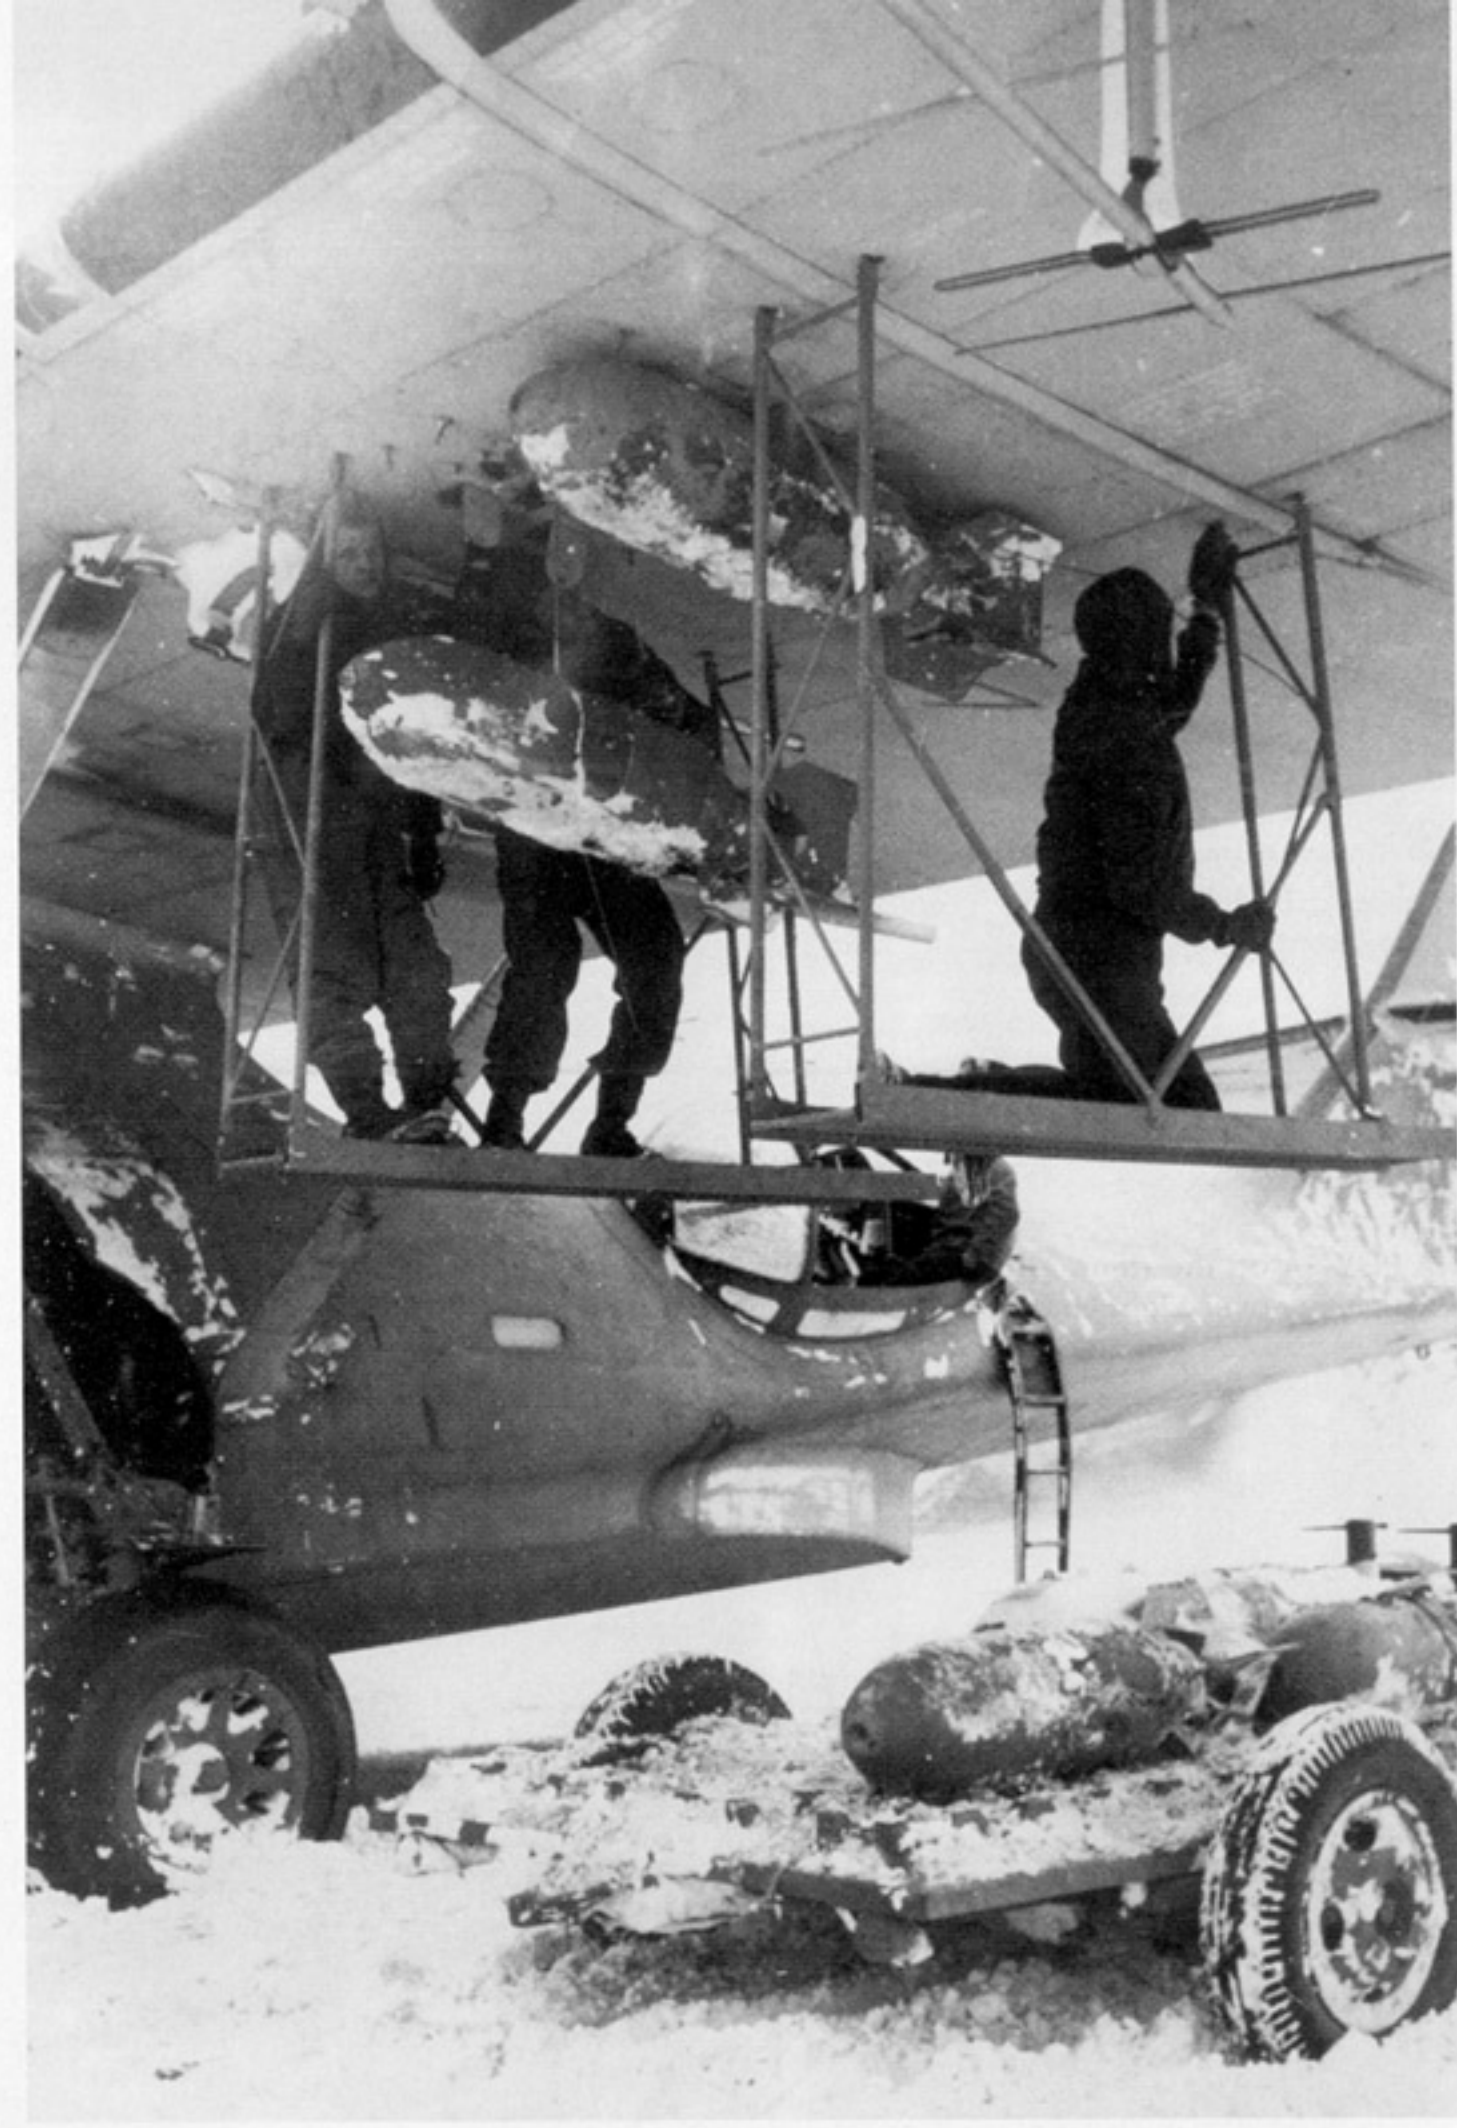
These crewmen are loading 500 pound General Purpose bombs on the underwing racks of a PBY-5A under harsh conditions at Cold Bay, Alaska on 23 November 1942. The antenna above the crewman at the right is a Yagi radar antenna. (George E. Earle)

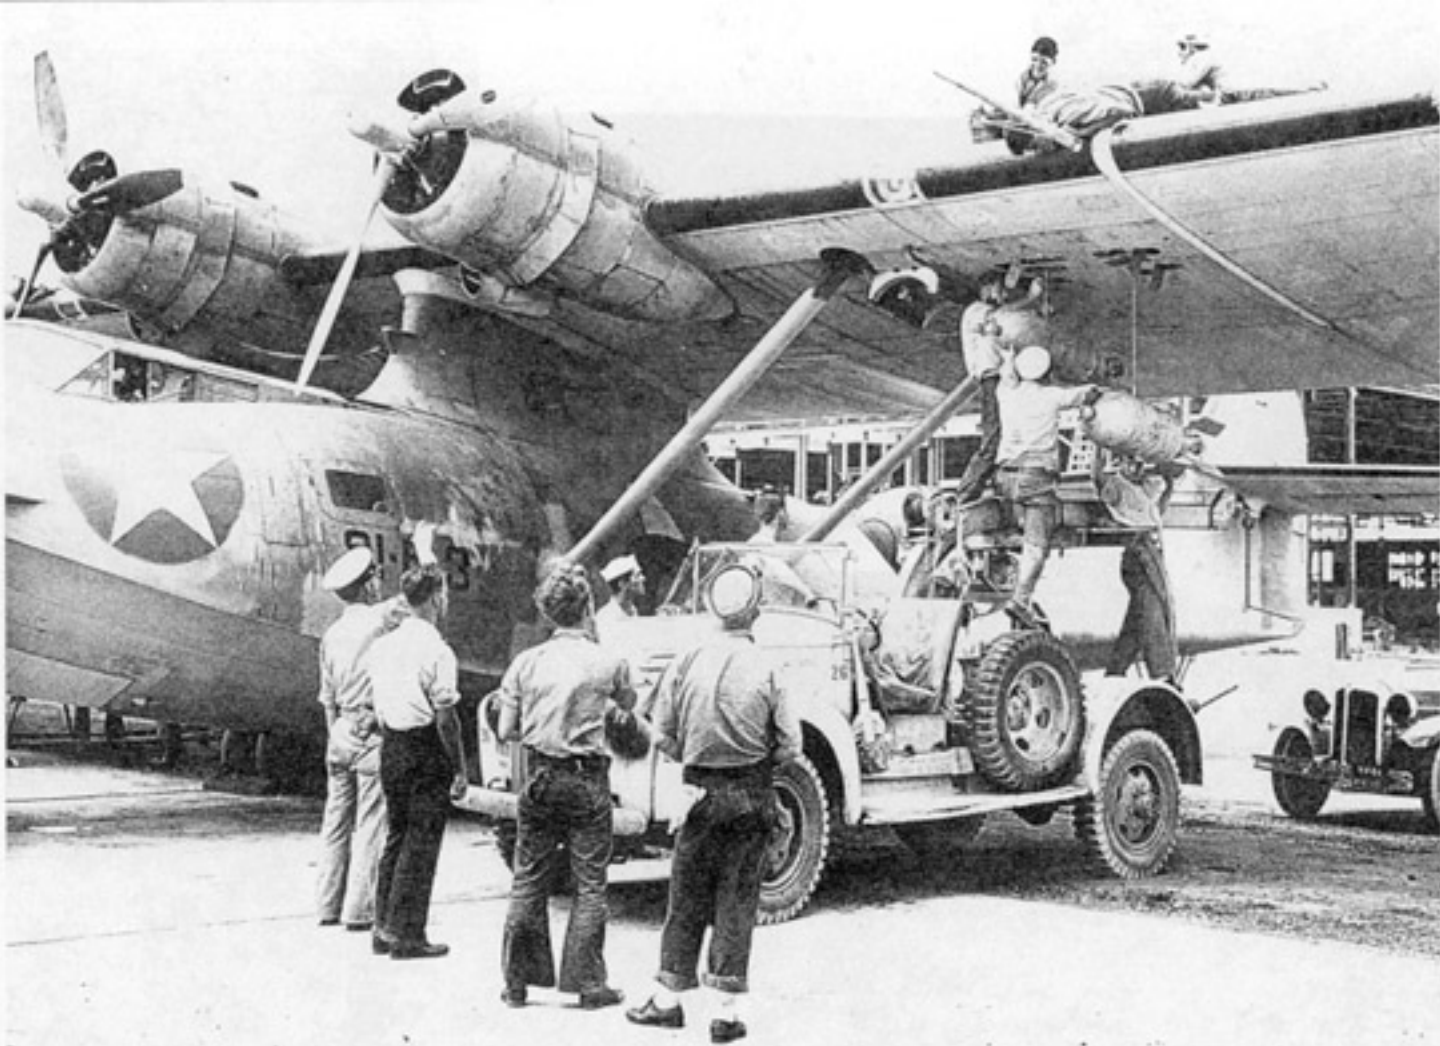
Crews transfer 500 pound General Purpose bombs from a weapons carrier to the underwing racks of a PBX-5A of VP-91 on Midway Island on 5 June 1942. A torpedo rack is installed between the bomb rack and wing strut. (National Archives)

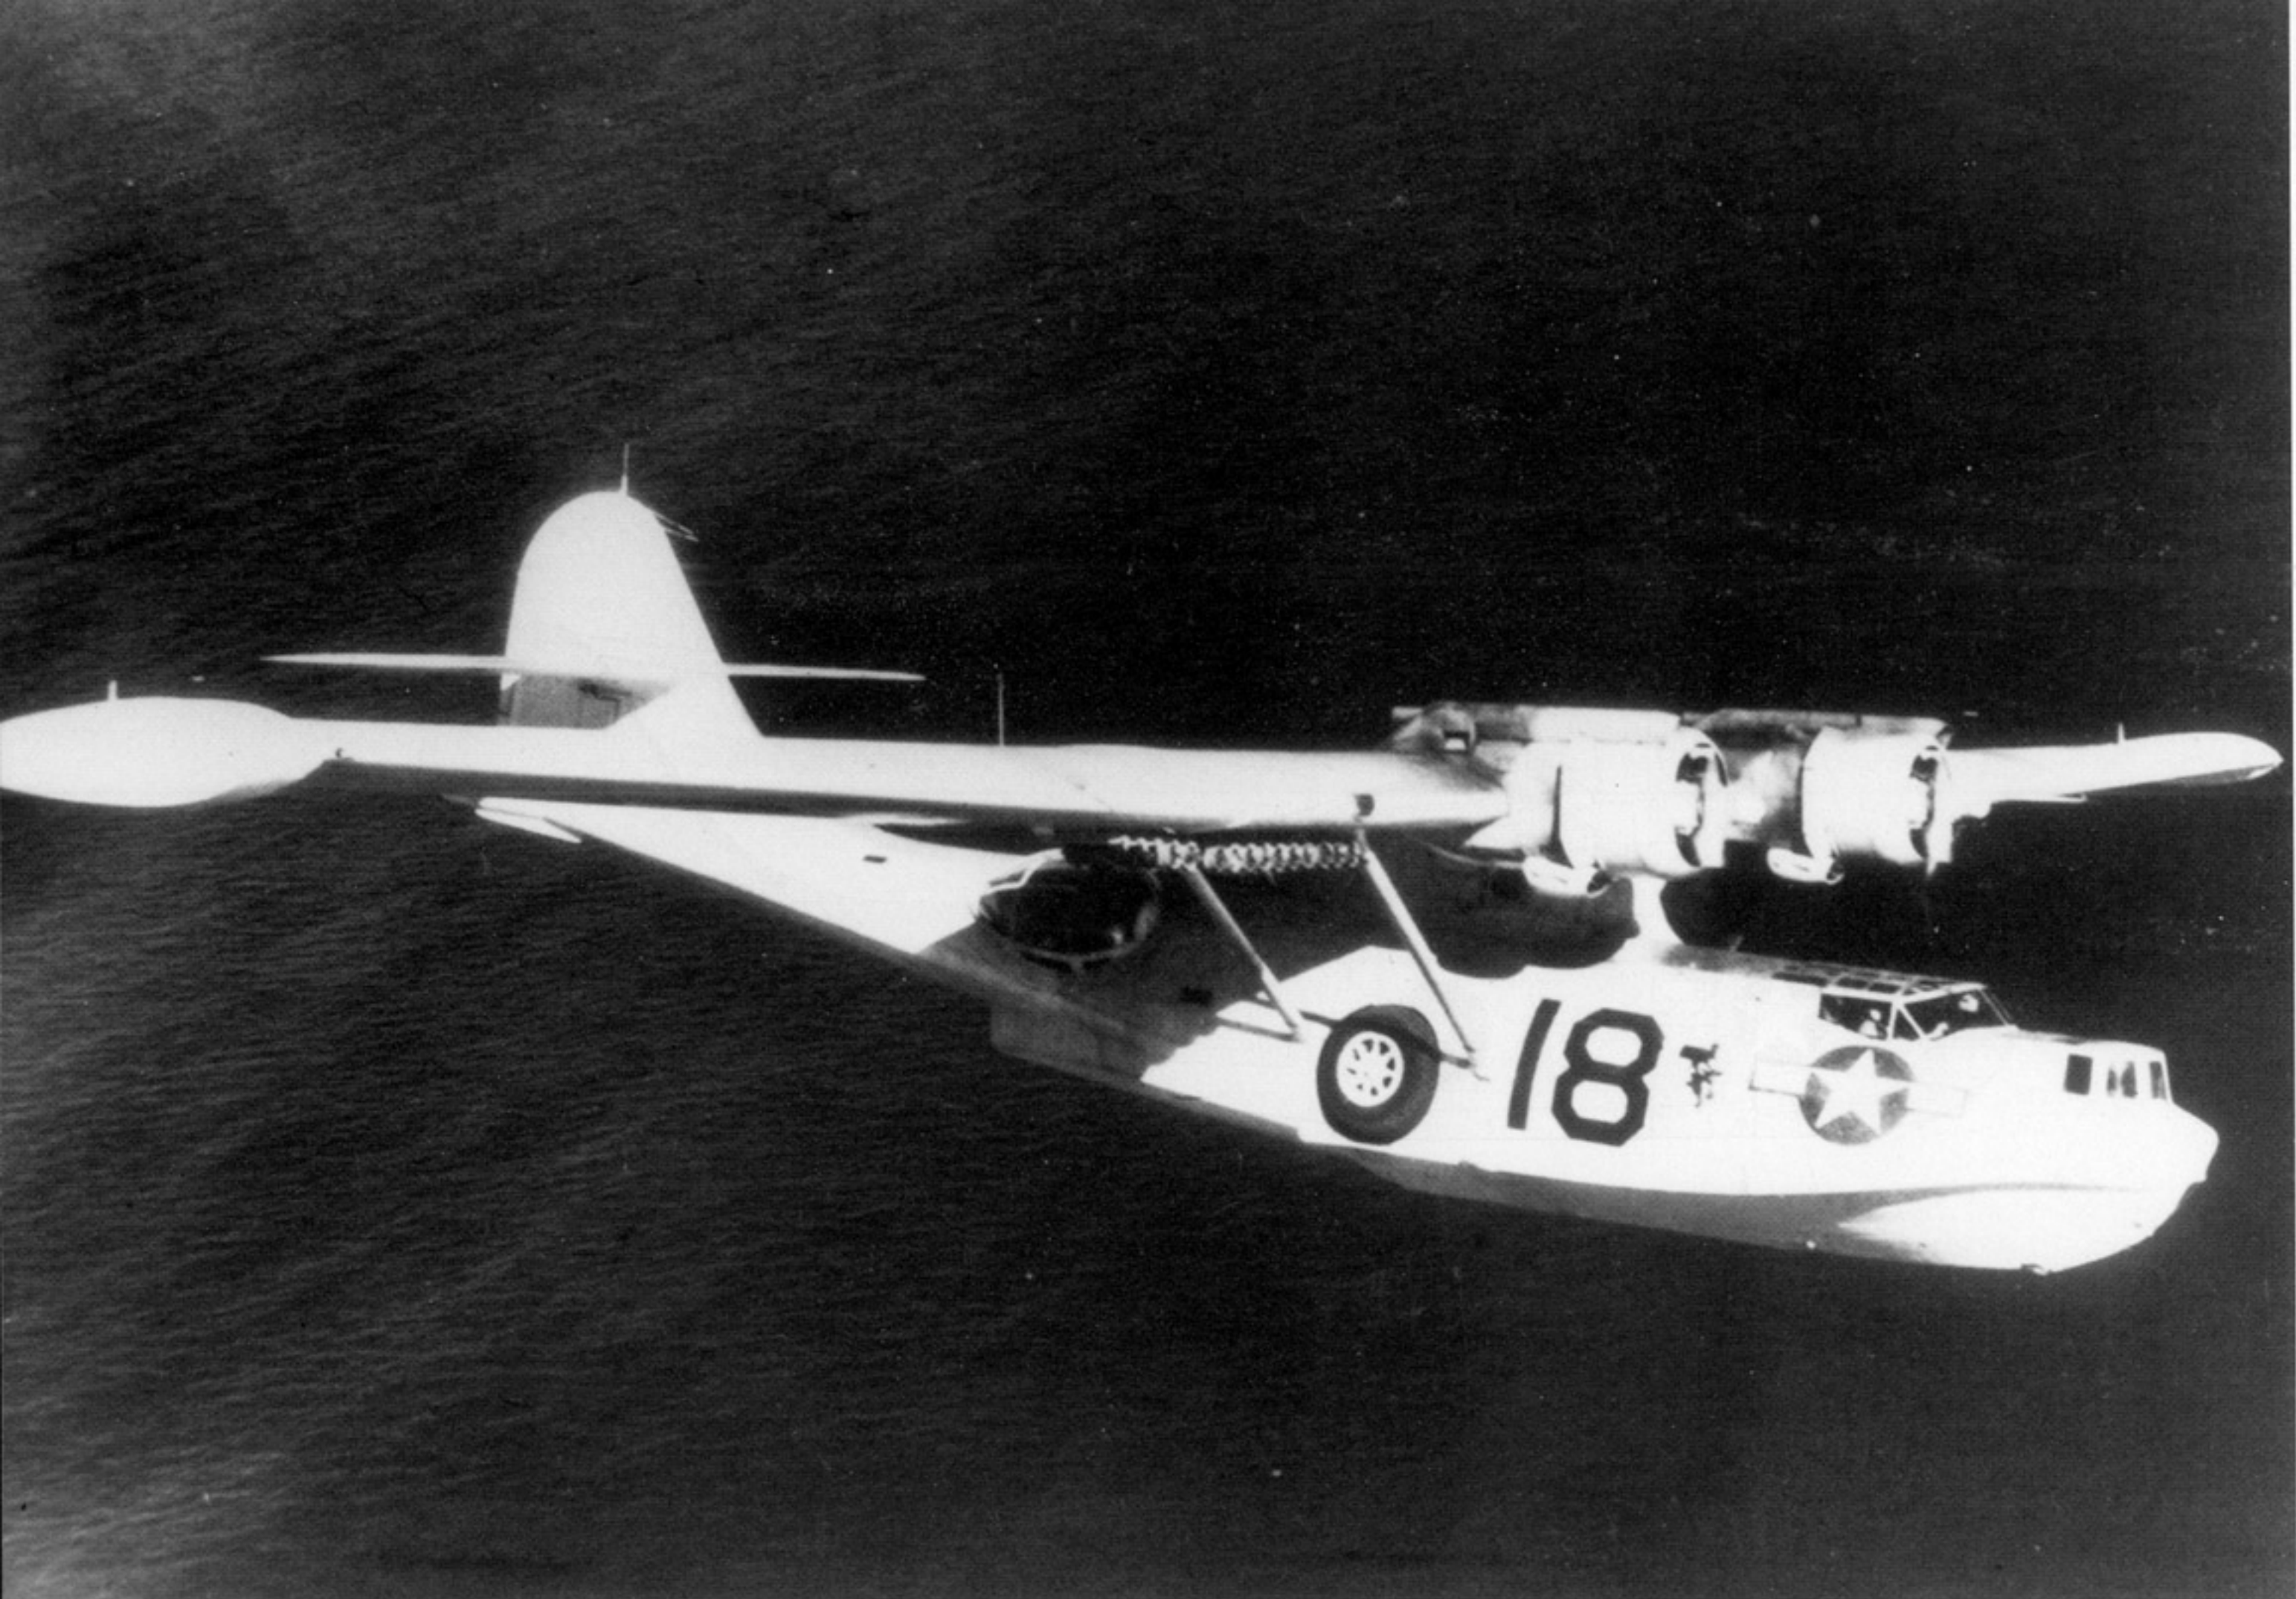
PBY-5A, side number 18 of VP-63 during 1944, is fitted with tail mounted MAD gear. The aircraft is armed with anti-submarine retro rockets under the wings and has exhaust shrouds fitted for thermal wing deicing. The aircraft was painted in the anti-submarine scheme of Sea Gray upper surfaces over White . (USN

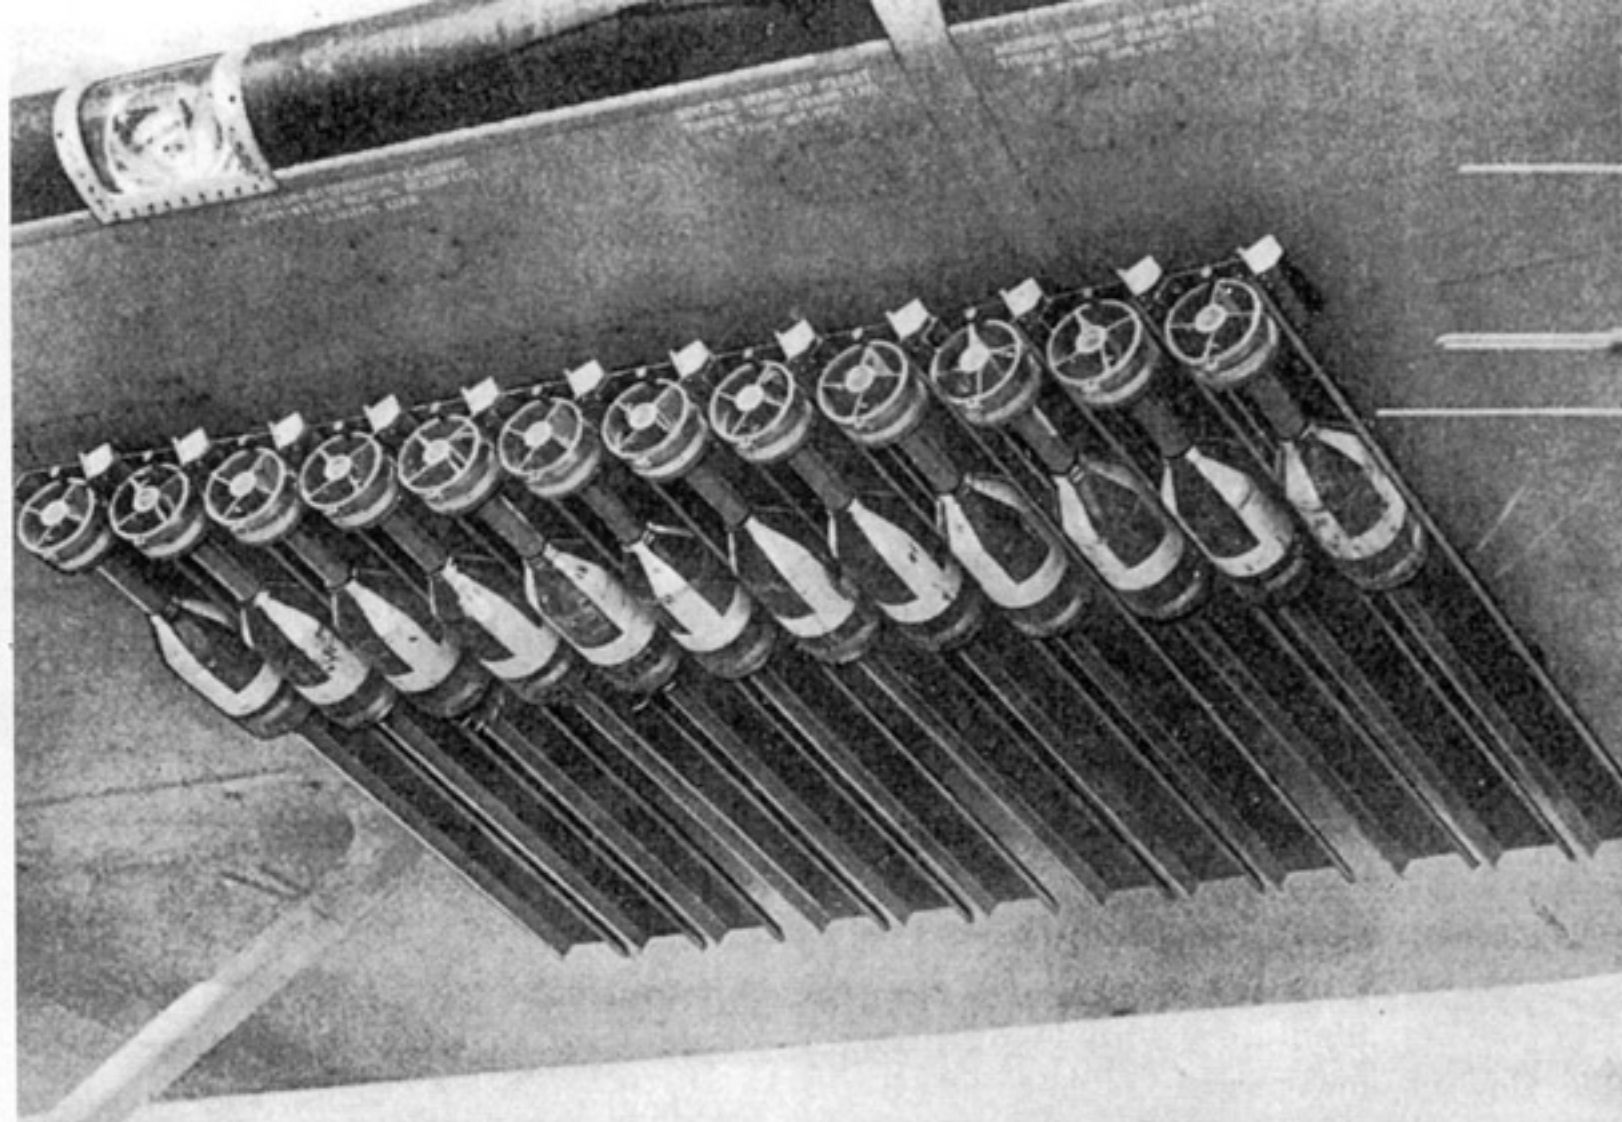
Anti-submarine retro rockets under the port wing of a PB4Y. Retro rockets were developed by the California Institute of Technology (CIT) during the Second World War. The 65 pound 2.25 inch rockets carried a contact-fused explosive charge which avoided alerting a submarine to the presence of the aircraft if the rocket missed. A direct hit could produce significant damage. (USN)

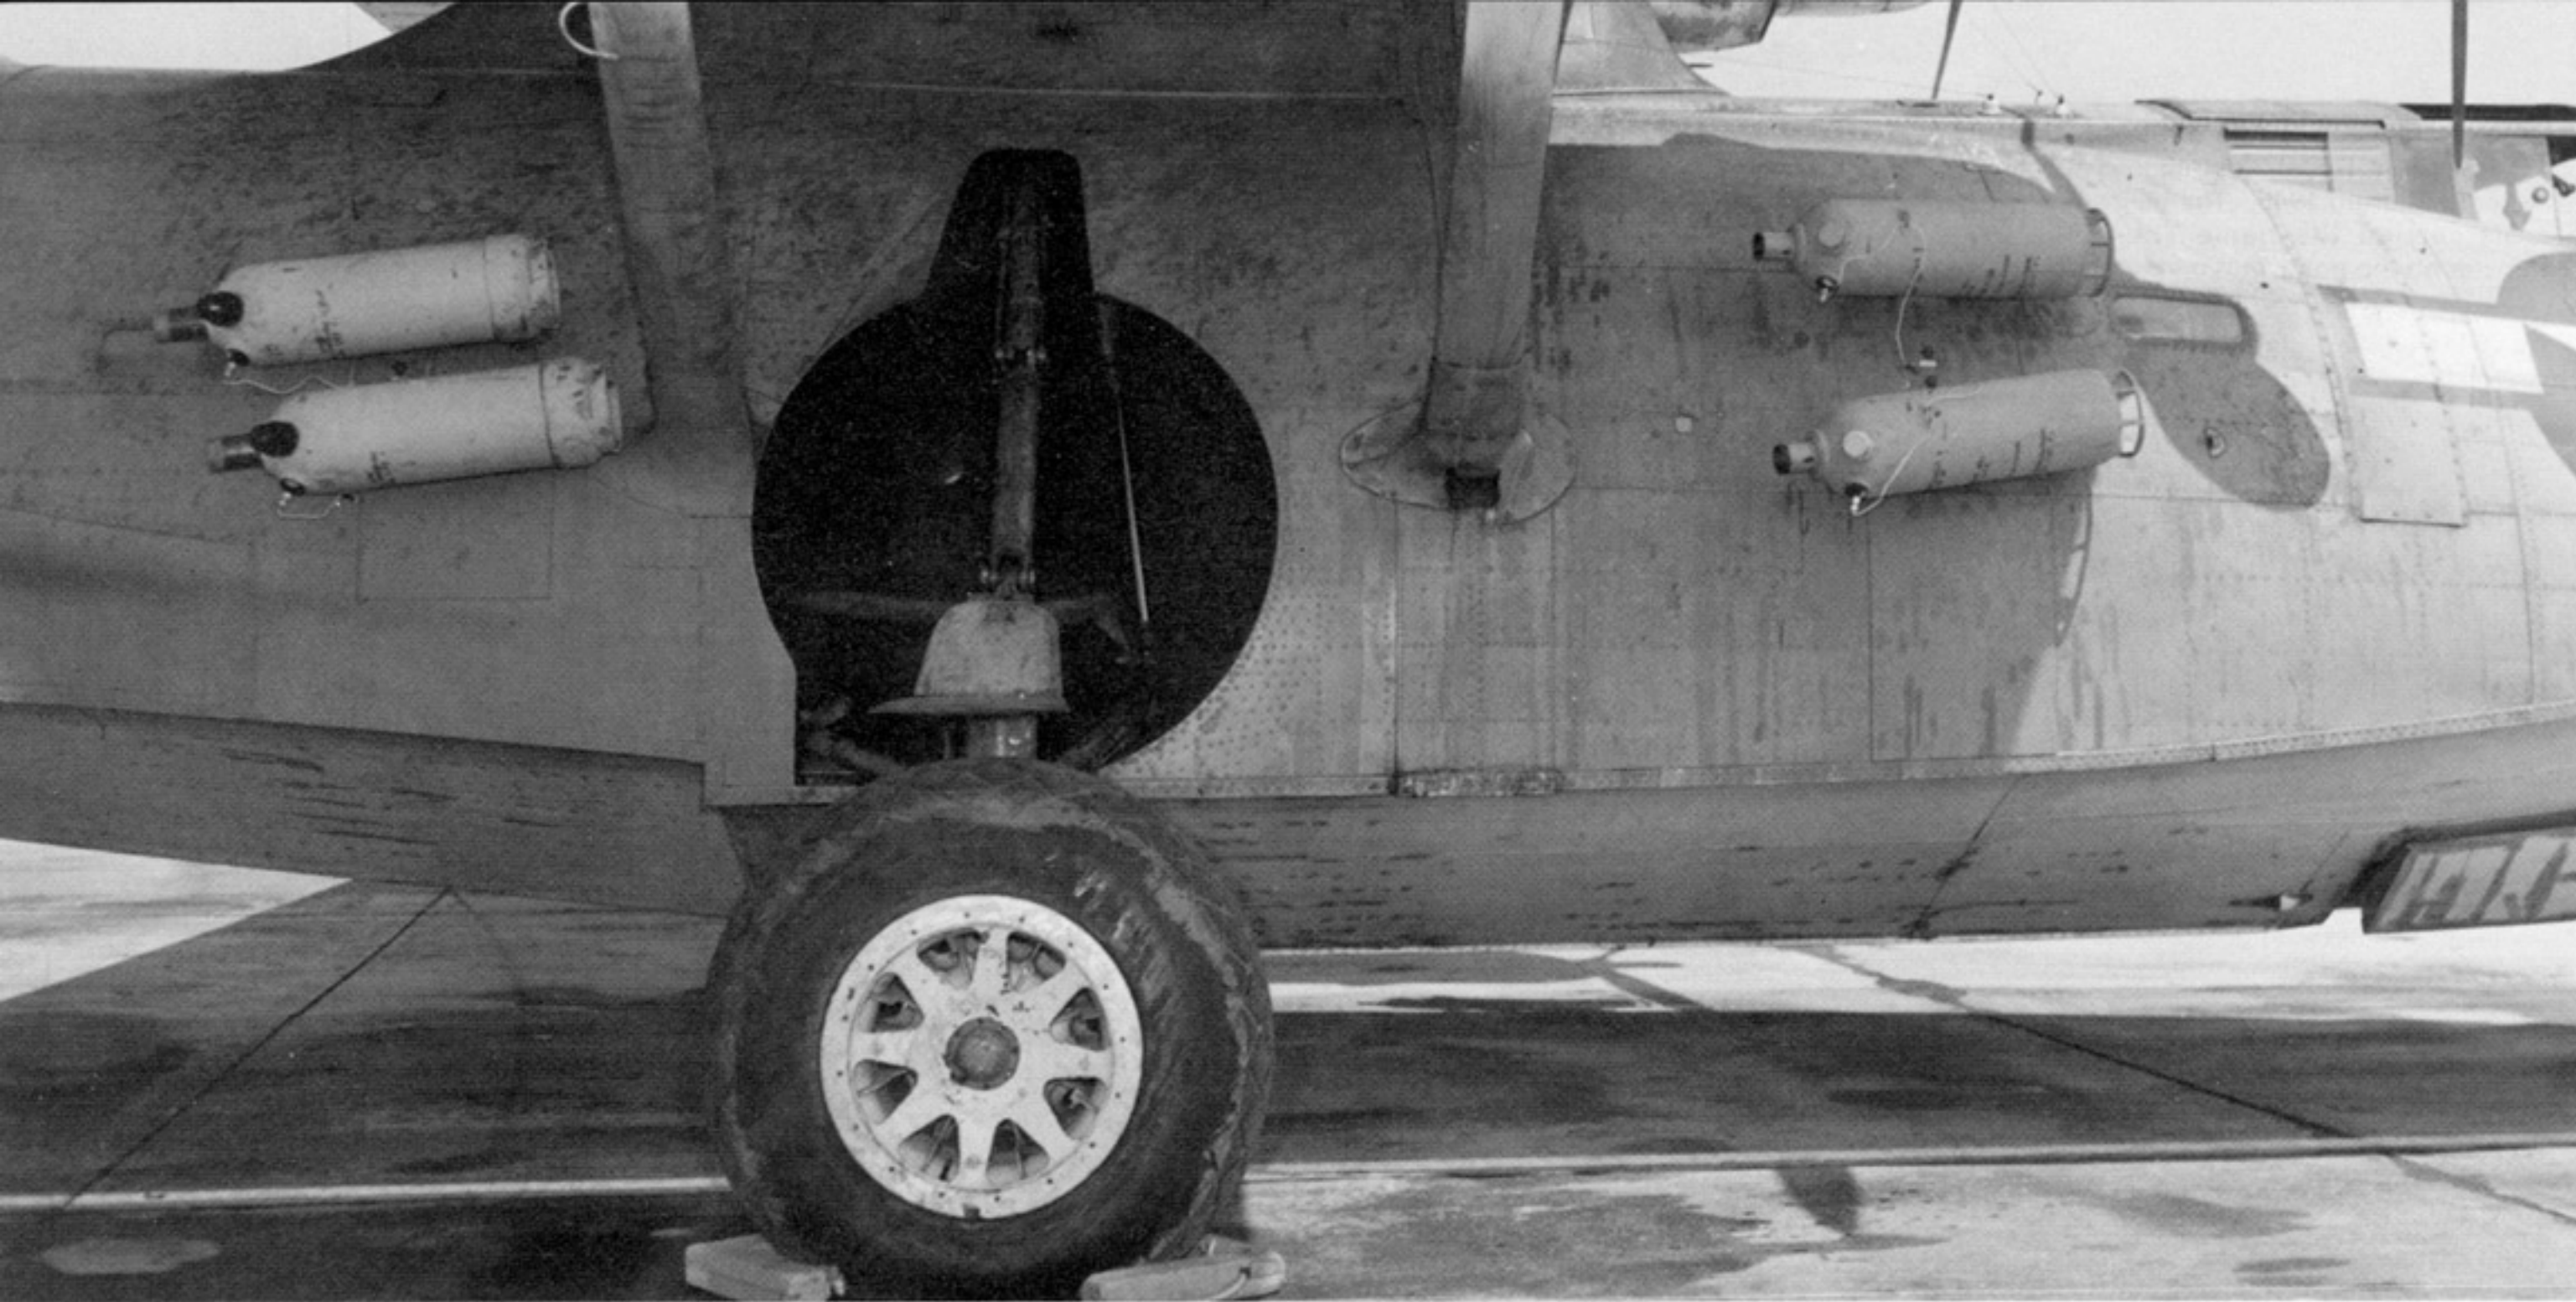
The starboard Jet Assisted Take Off (JATO) bottle installation on a PBY-5A (BuNo 04406) on 2 June 1945. The aircraft could carry eight JATO bottles, four on each side and these could be fired either all at once, or in pairs (forward and aft) . (USN)

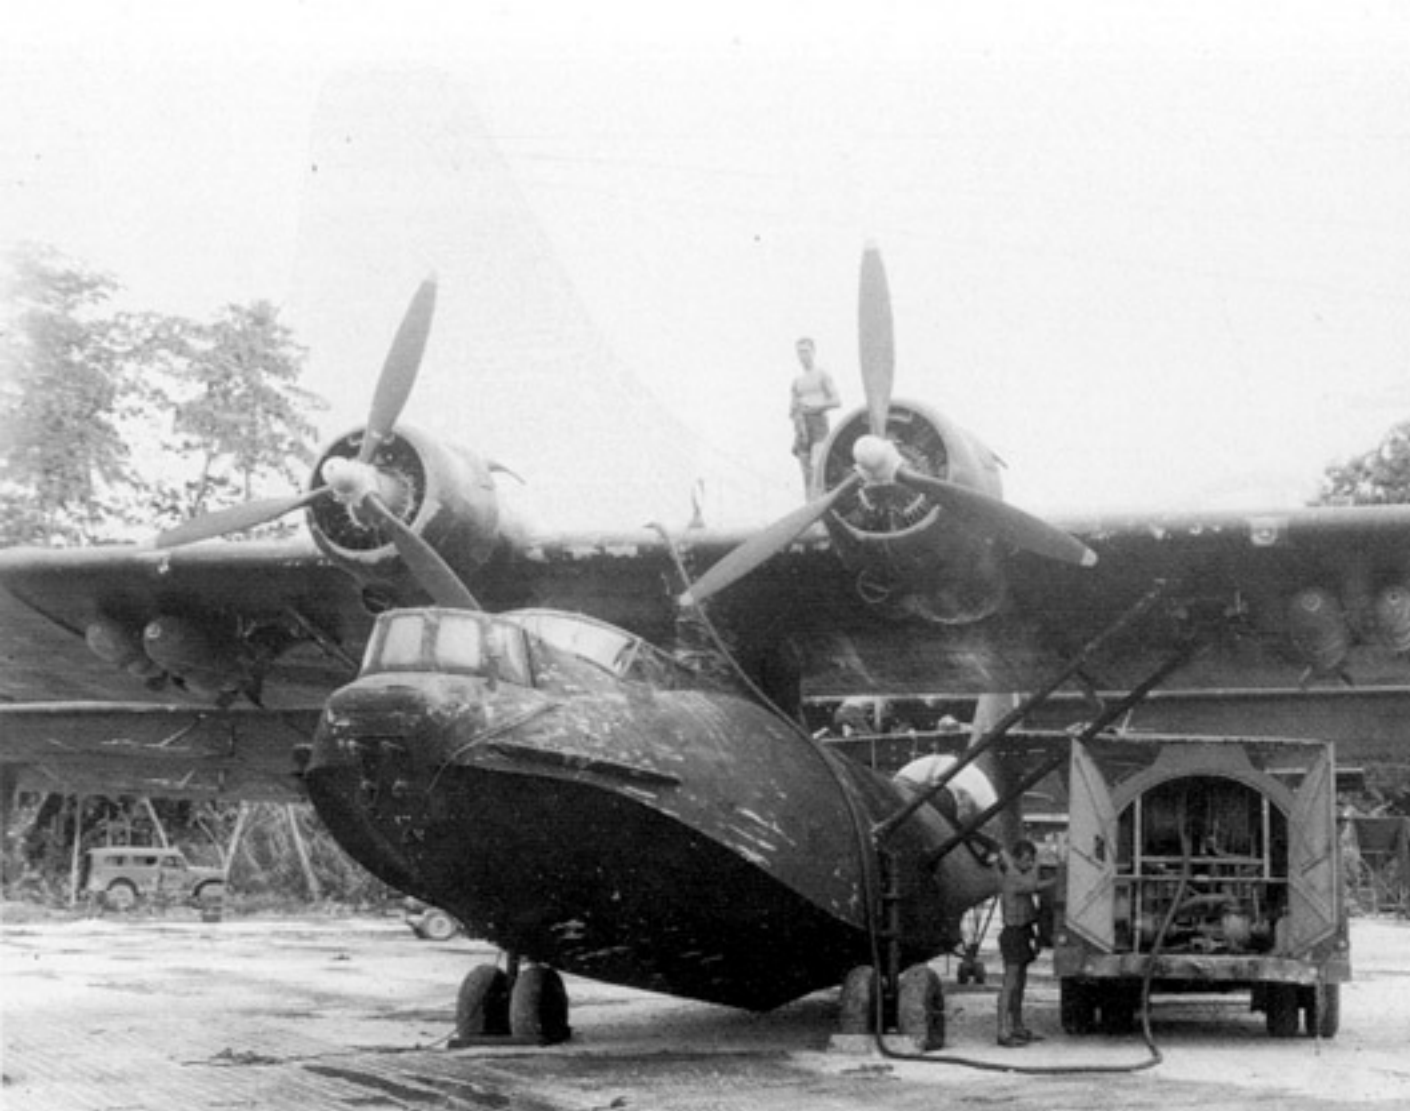
A PBY-5 Black Cat of VP-34 was shore-based at Samarai, on 3 March 1944. It was outfitted with an experimental fixed nose gun battery of four .50 caliber guns. Its typical bomb load was made up of 500 pound bombs hung outboard and 1,000 pound bombs hung inboard. (National Archives via Dave Lucabaugh)

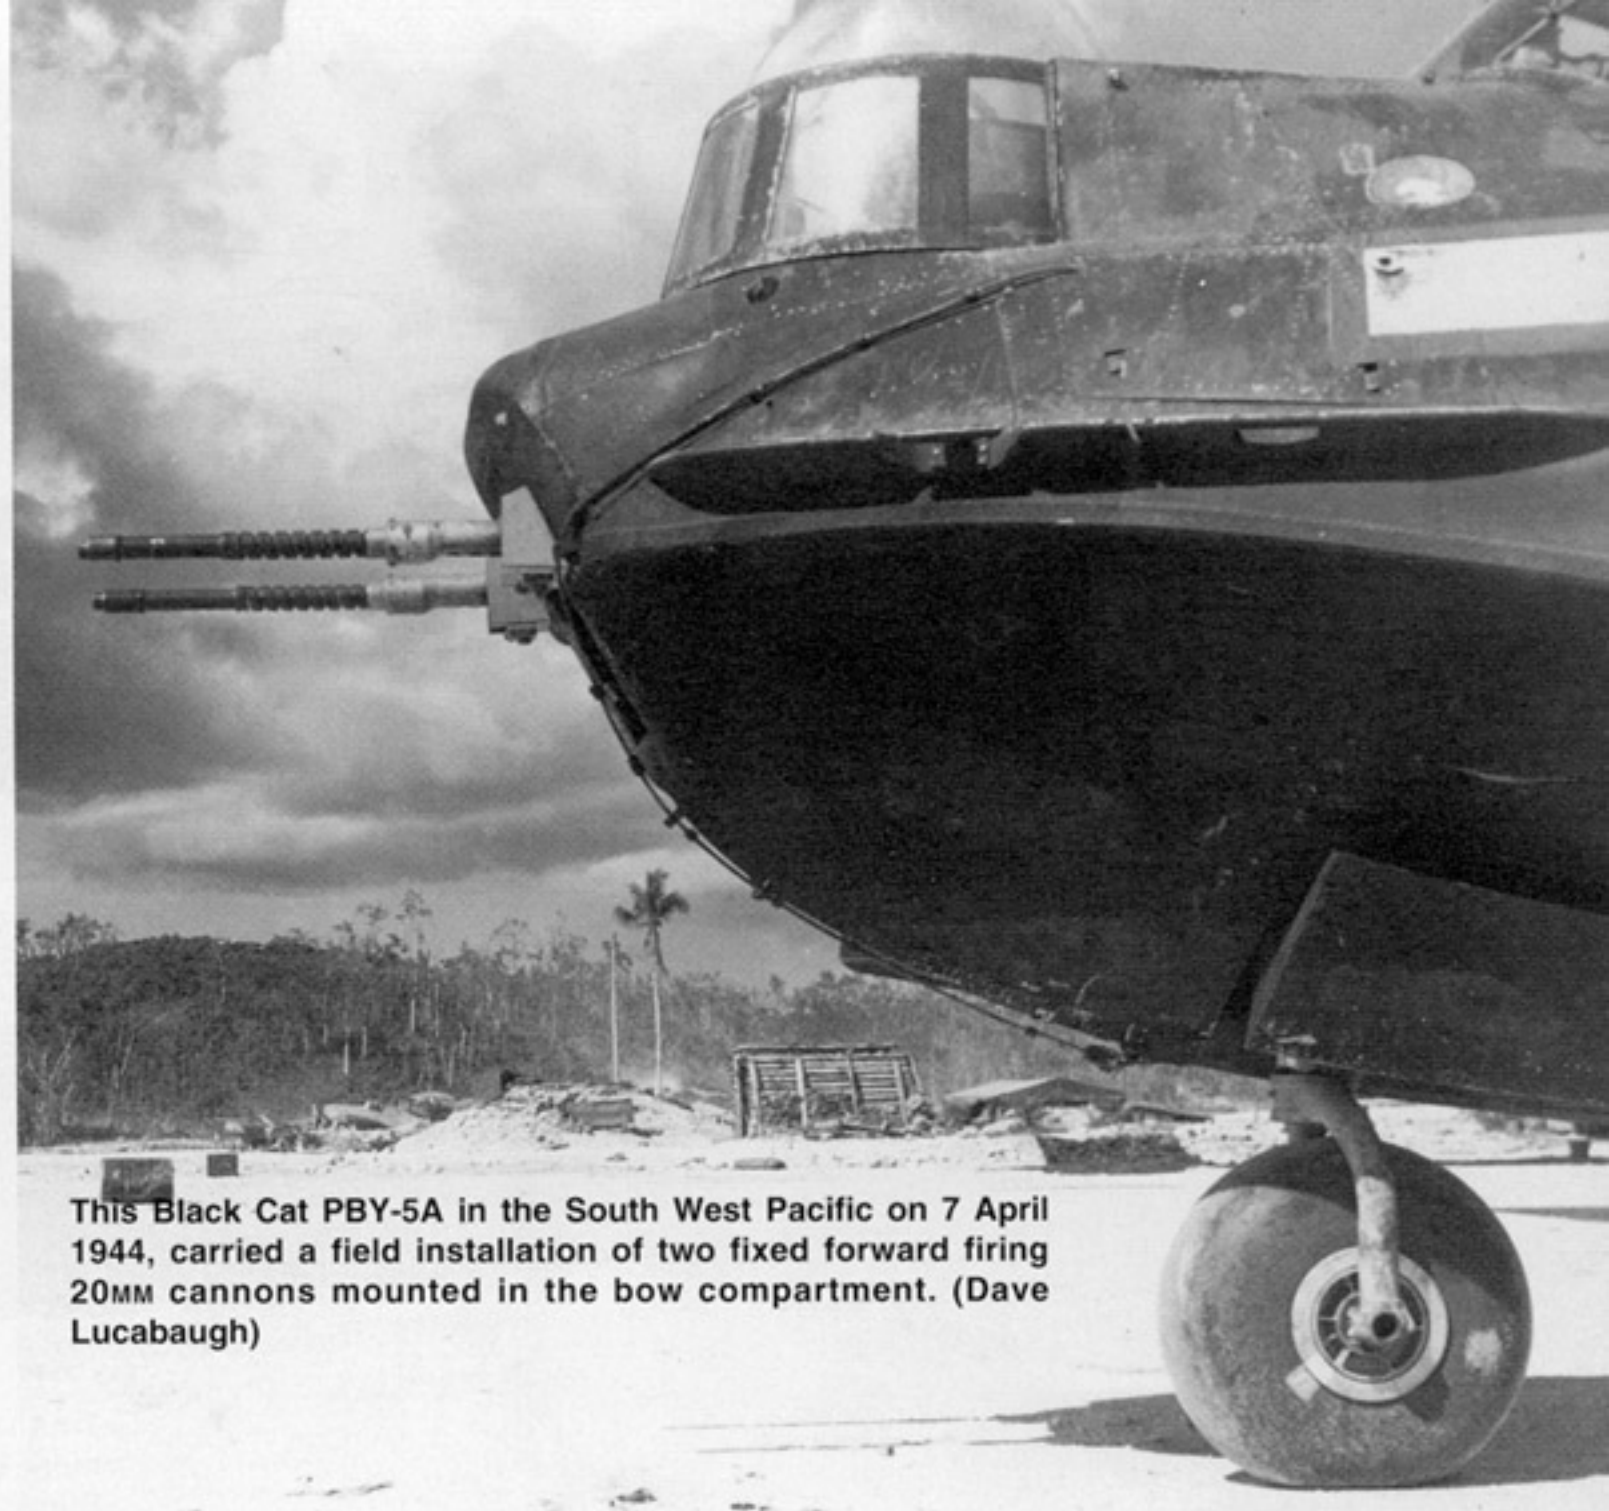
This Black Cat PBY-5A in the South West Pacific on 7 April 1944, carried a field installation of two fixed forward firing 20mm cannons mounted in the bow compartment. (Dave Lucabaugh)
